Building Inspection Report

11111 SW 111 St. Miami, FL. 33111

Inspection Date: August 11, 2011

Report Number:F080310

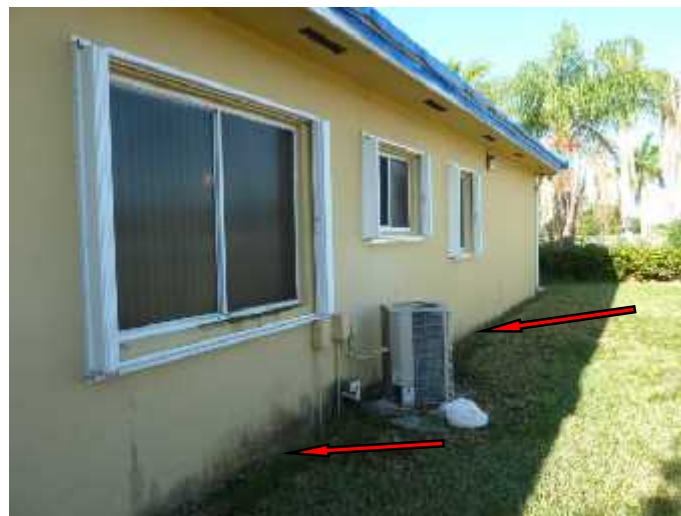
Photo: View of the North Elevation.

Note: Stains on walls are a result of this area flooding and not draining properly.

- **Repair:** As a minimum additional properly selected, placed and compacted fill material is recommended around the foundation.

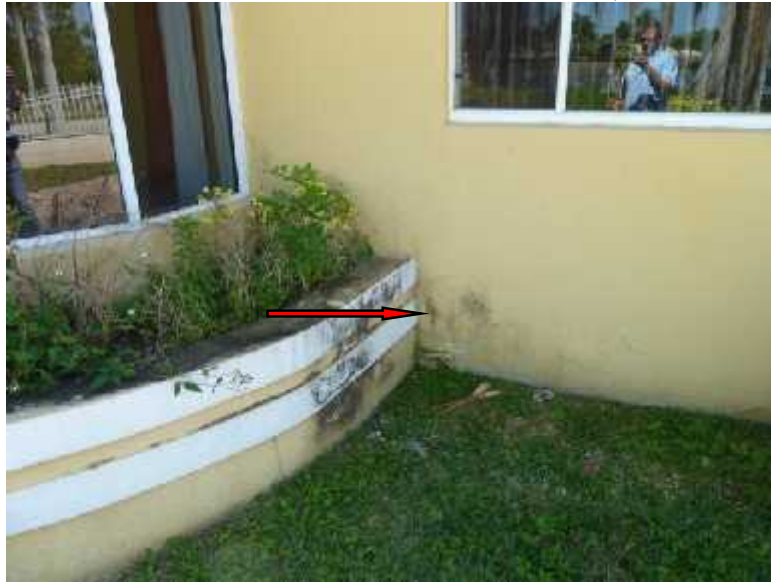
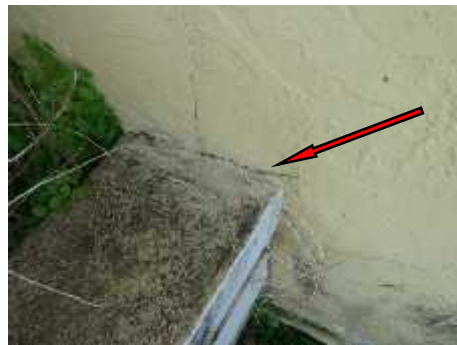
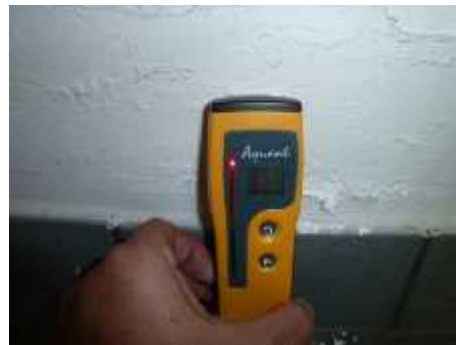
- **Repair:** Cracks were noted around the perimeter of the garage. It is very common for shrinkage and/or settling cracks to develop at the foundation walls juncture. It is also common for these cracks to leak. If leakage is experienced, improve lot drainage adjacent to the crack. If leakage persists, patching with an epoxy resin or hydraulic cement and exterior repairs after excavation. The exterior repair, is often successful in eliminating leakage.

- **Repair:** Localized damage of the stucco exterior walls (staining and or cracks) should be repaired. There is extra risk of hidden damage in such areas caused by previous or present leaks that should be sealed.

Photos: View of the Planter to the right of the front entrance.

Note: The exterior surface cracks have led to water intrusion to the garage. Moisture was detected using a GE Aquant moisture meter.

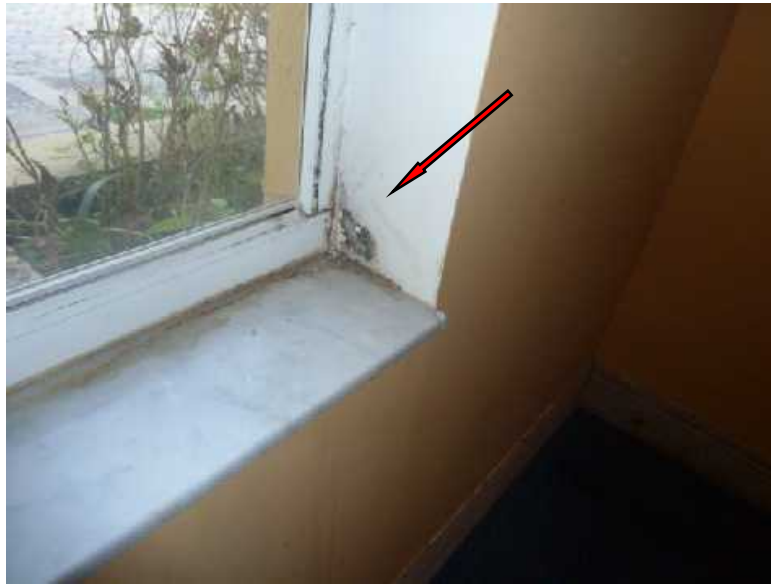
- **Repair:** Localized evidence of rot was visible at window sills. Repairs should be undertaken in when painting.

**Photo: View of the window in the left front bedroom.
Note: There is a risk of hidden damage**

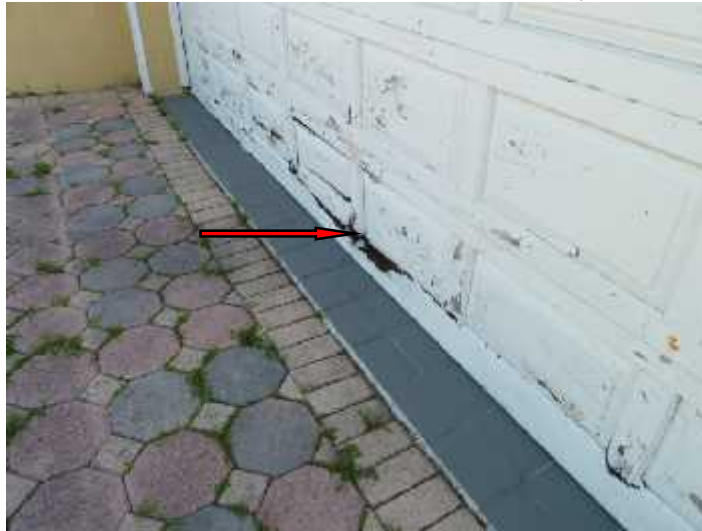
- **Major Concern, Repair, Safety Issue:** The overhead garage door is substantially rotted. It should be replaced.

Photo: View of the Exterior of the Garage Door

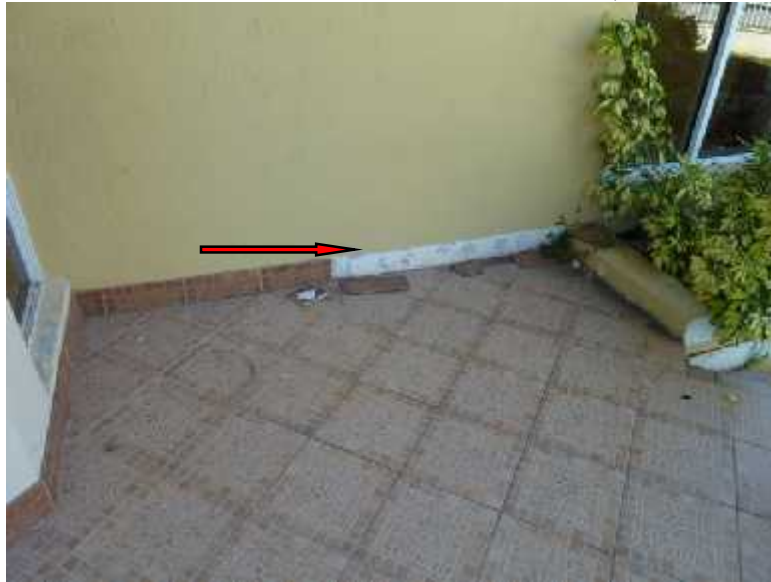
- **Monitor:** The tiles on the front porch are deteriorating noticeably. Repairs or rebuilding may eventually be needed here.

Photo: View of tiles on the Front Porch.

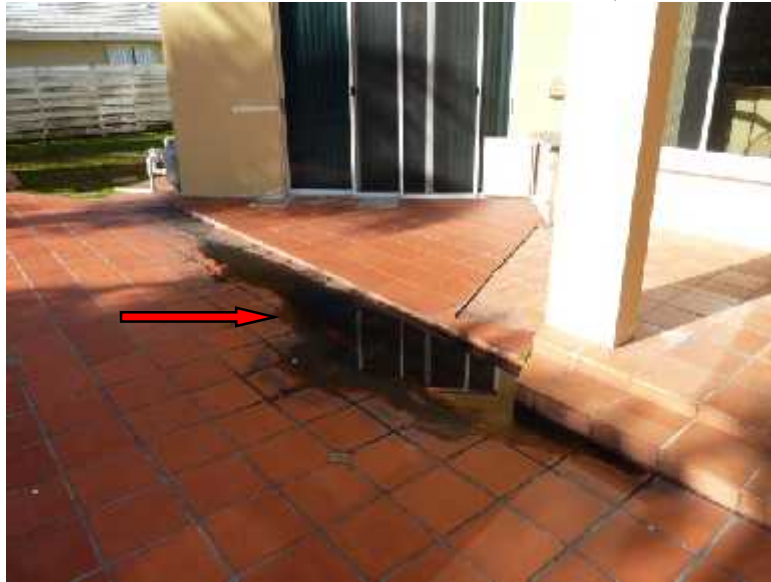
- **Possible Major Concern, Monitor:** The patio between the pool and the house slopes towards the house. This condition can cause water to pond and possibly send water entry in the building. Unfortunately, it is difficult to improve this situation without resurfacing the driveway adjacent to the foundation or by adding a special intercept drain at the foundation wall. (See Photo on next page)

**Photo: View of the Rear patio. There is a need for a drain to divert water away from the foundation.
Note: Multiple layers of tiles have been installed.**

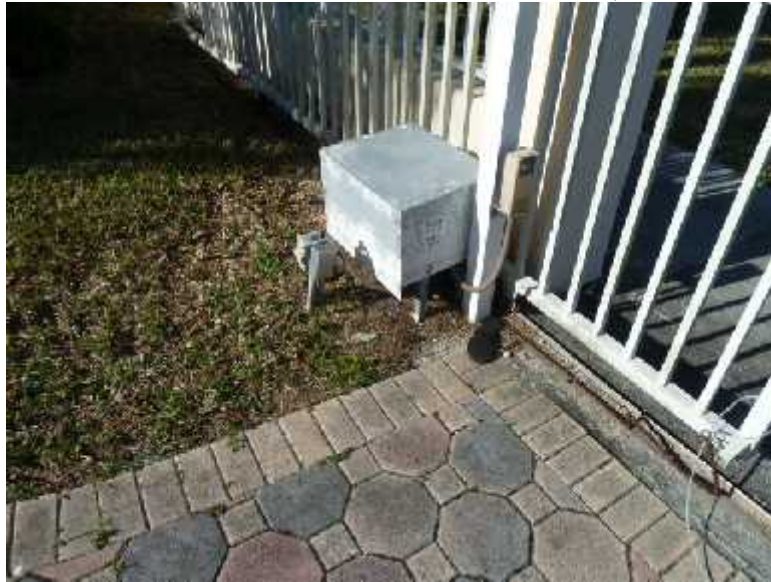
- **Repair:** The gates at the front entry does not operate. Recommend further investigation by a specialist to determine remedies and repair as needed.

Photo: View of one of two gate openers on the property. Both openers were inoperable.

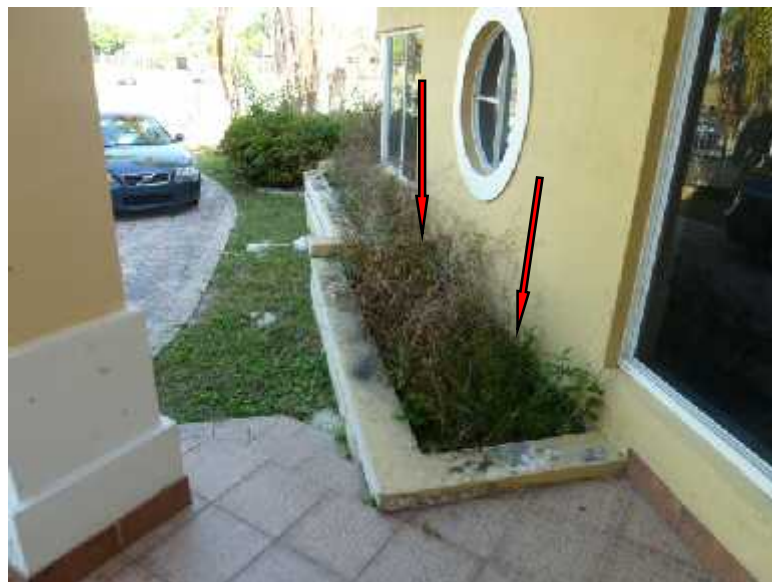
- **Monitor:** The concrete planters installed at the front of the property should be closely monitored for water intrusion.
- The planters hold soil against the exterior walls of the property above grade. This means that the interior or the planter or exterior wall must be sealed with a flexible vapor barrier.. Should this seal or vapor barrier fail it will lead to water intrusion into the building. (See photos on next page.)

Photo: View of planters to the left of the front entrance.

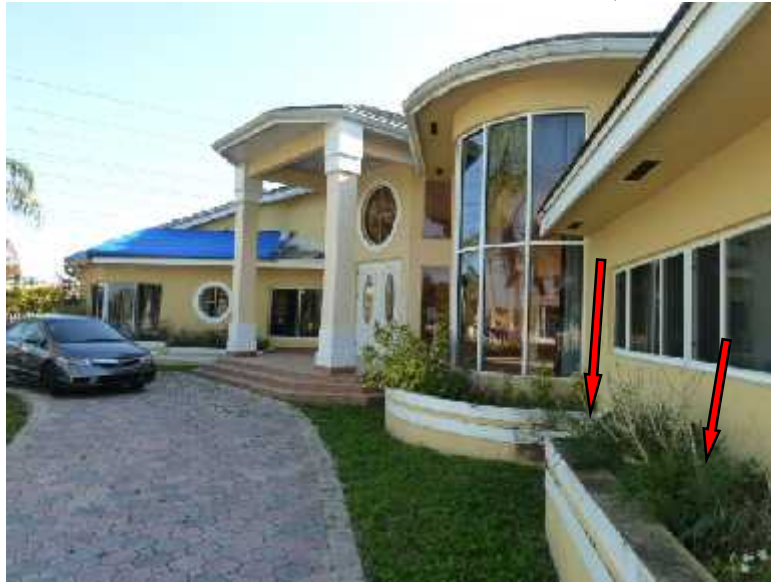
Photos: View of the planters at the front elevation.

- **Monitor:** The concrete planters at the front elevation do not have weep holes at the bottom to allow water to escape during heavy rains. Water damage to the interiors was noted surrounding the planter adjacent the garage.

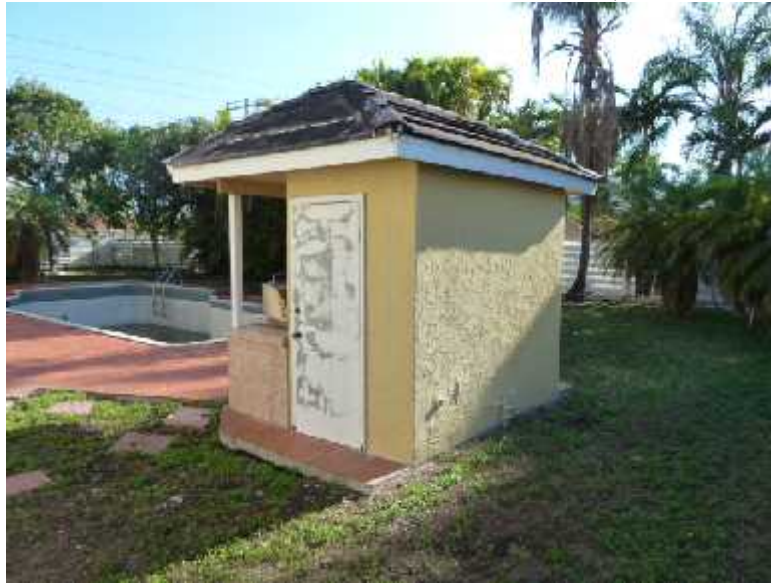
Photo: View of the structure at the rear of the property. This structure has a bathroom, shower and a barbecue. The building is not connected to the plumbing system of the home. Electricity appears to have been disconnected.

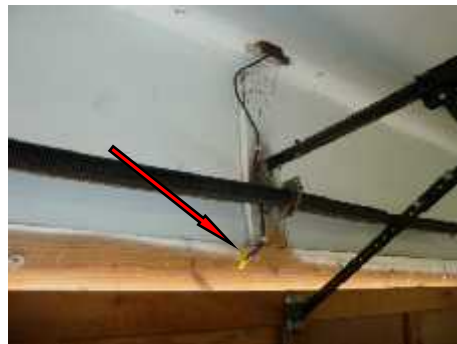
Garage

Photo: View of exposed electrical connections

- **Repair:** All junction boxes should be fitted with cover plates, in order to protect the wire connections.
 - This is for safety of personnel, the actual wiring connections themselves and for fire prevention purposes.

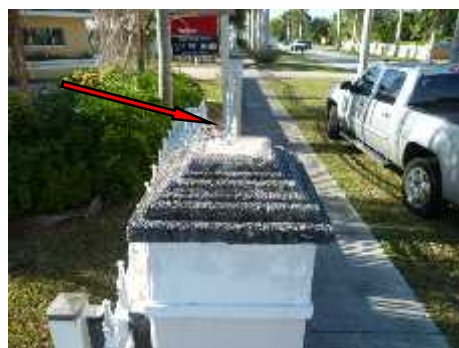
Missing Coach Lamp

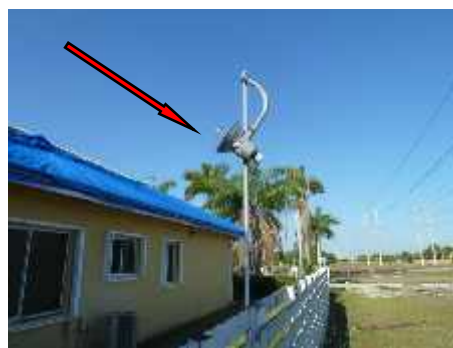
Damaged Flood Light

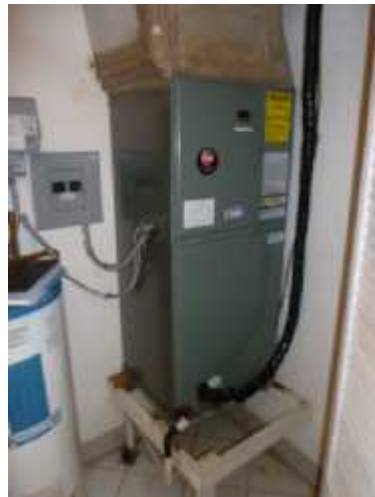
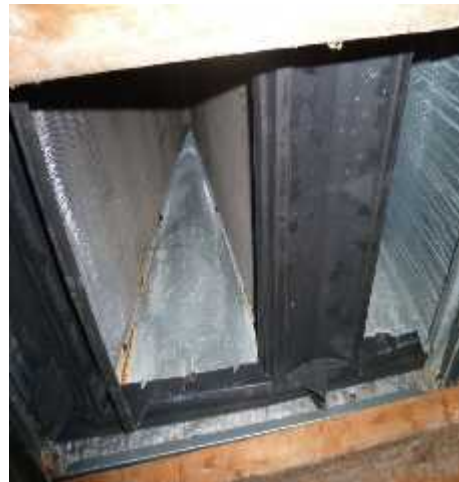
The air conditioning system is in need of servicing and/or repairs.

Photos: View of the air handler and the interior coils

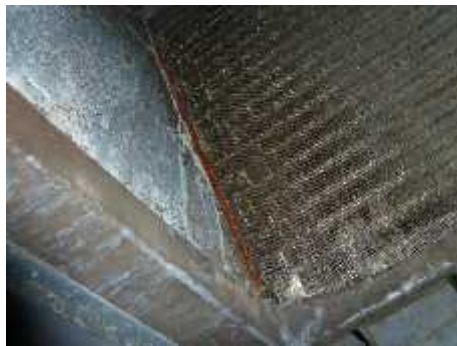
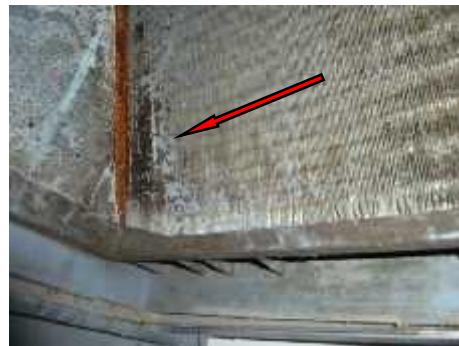
- **Repair:** What may be mold and/or mildew were observed at the coils in the air handler.
- Biological issues such as mold may be an irritant *or worse* to certain individuals.
- For you information, remediation of biological issues can be very expensive and possibly difficult to completely remedy.
- For additional information, please consult with a qualified biological specialist.

The air conditioning system is in need of servicing and/or repairs.

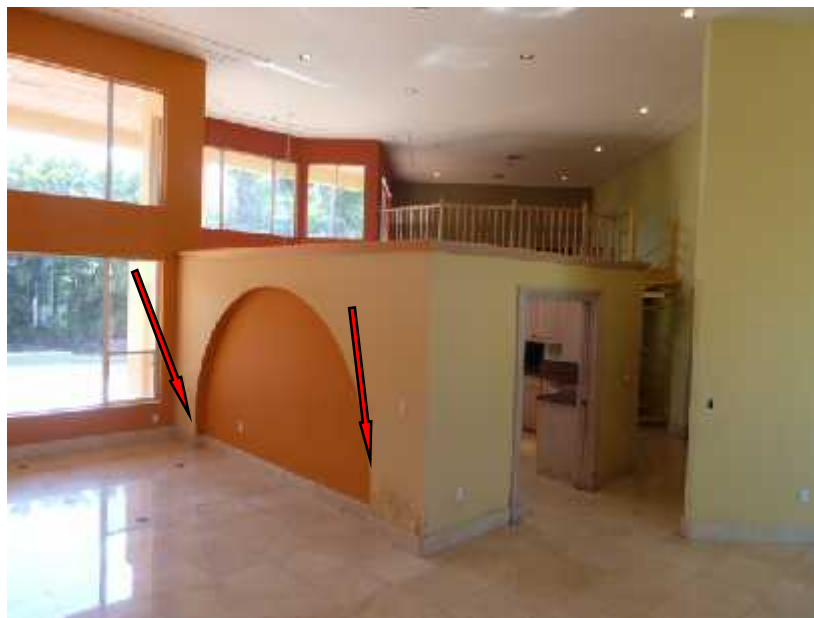
- **Monitor:** Apparent water staining was noted. Some areas were dry at the time of the inspection, due to the lack of recent rain we are unable to determine if the stain is still active. Recommend consulting with the current owners for additional information prior to closing. If the leak is still active, we recommend replacement of the roof prior to interior repairs.
- **Repair:** Water damage was noted throughout the interiors of the home. Virtually every room has some type of water intrusion or water damage.

Water Damage in the Living Room

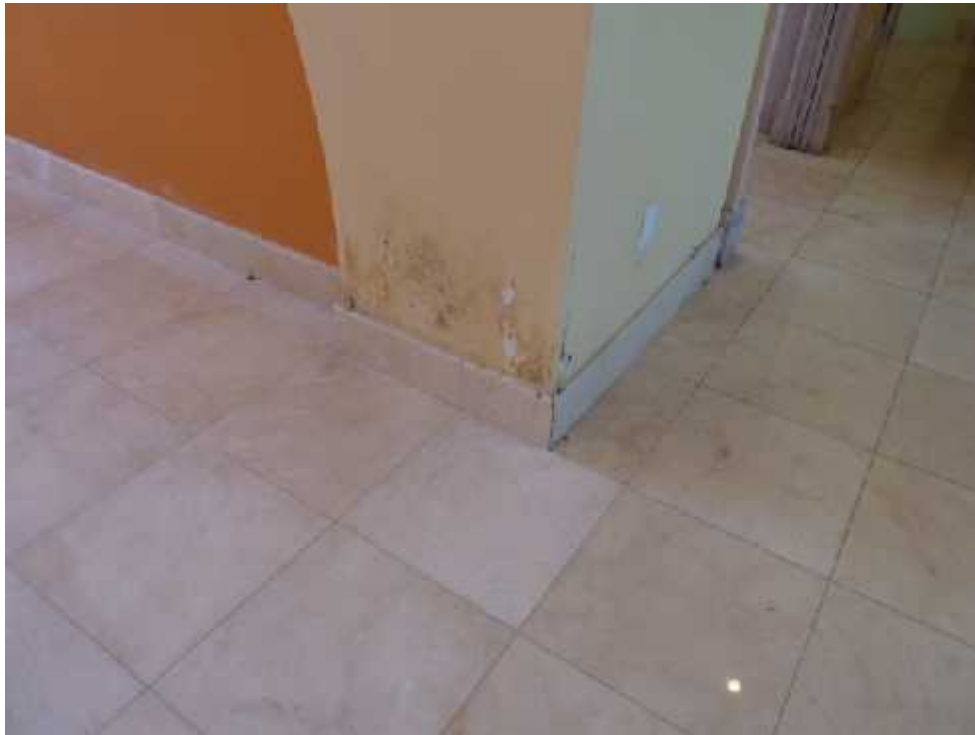
Close-up Living Room Floor

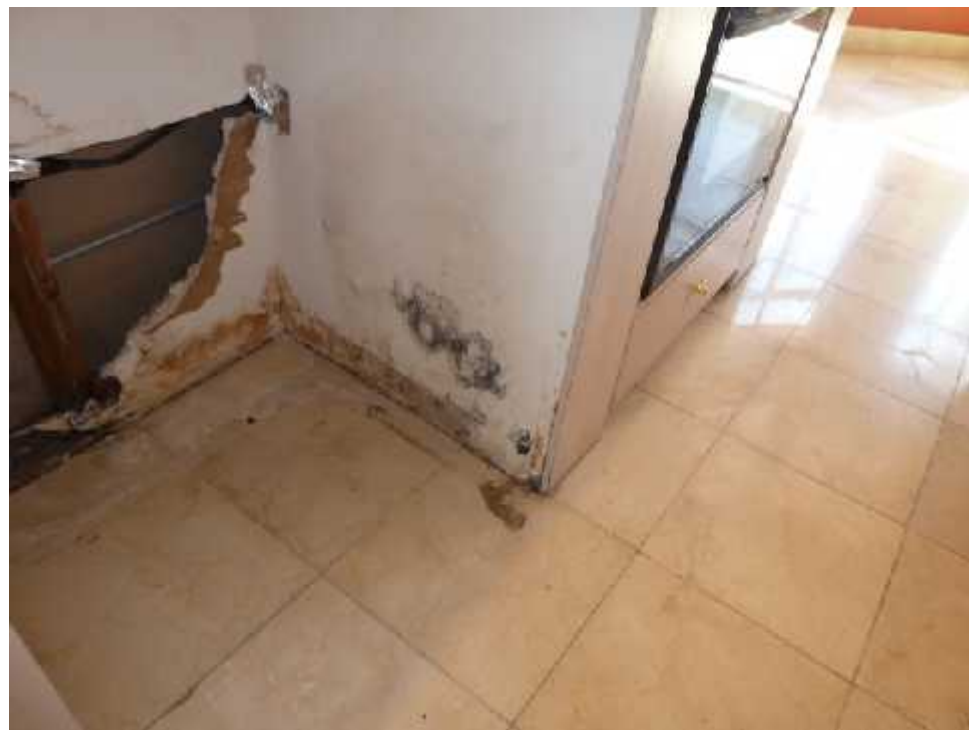
Damaged Kitchen Walls and Floor

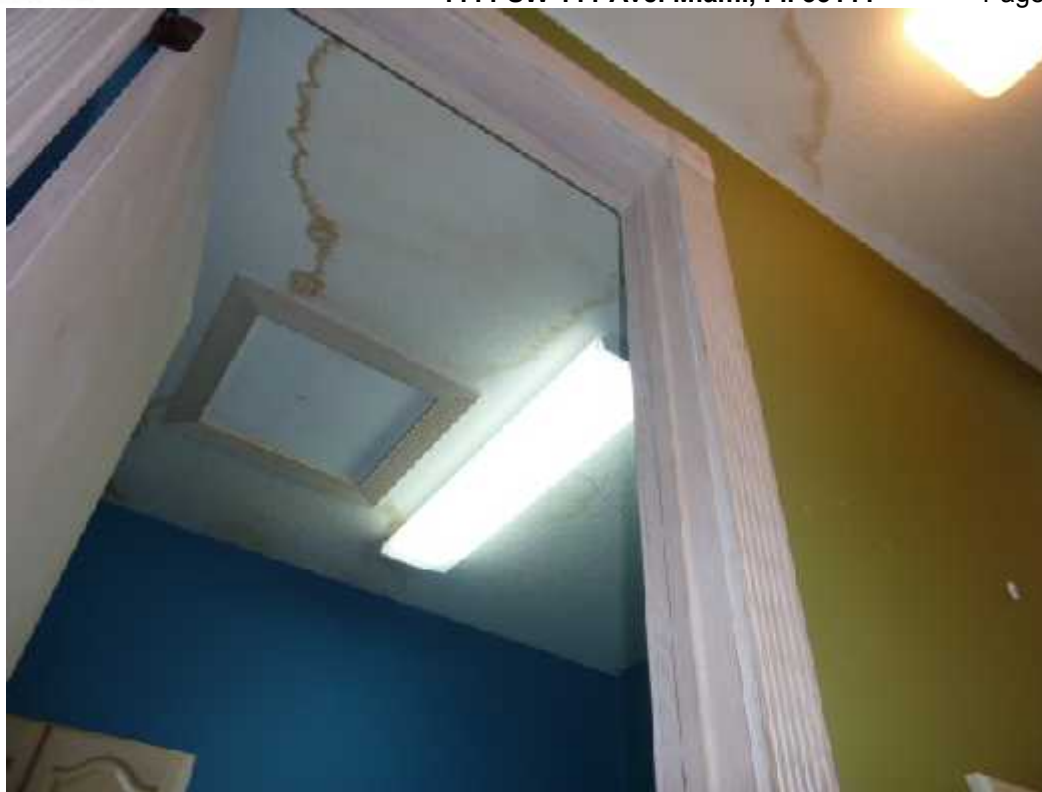
Hallway and Utility Room

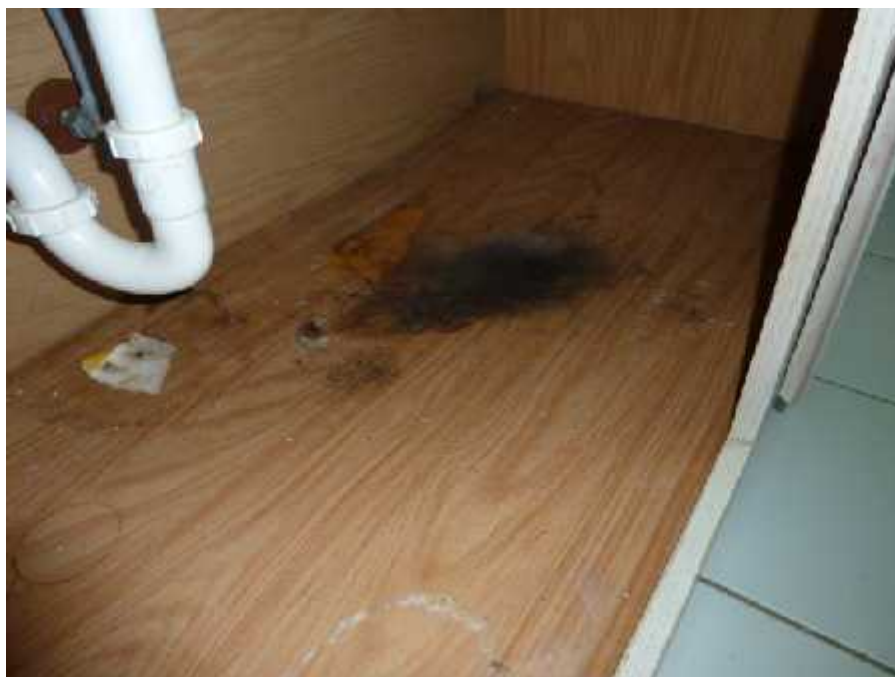
Damaged Cabinet in Utility Room

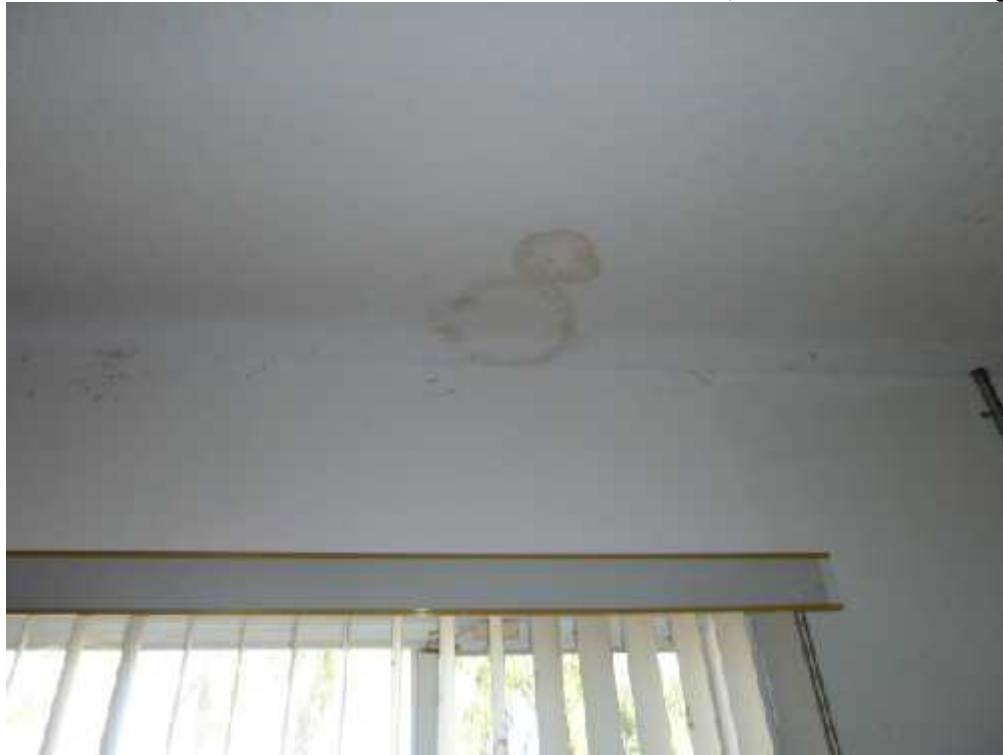
Ceiling In Garage

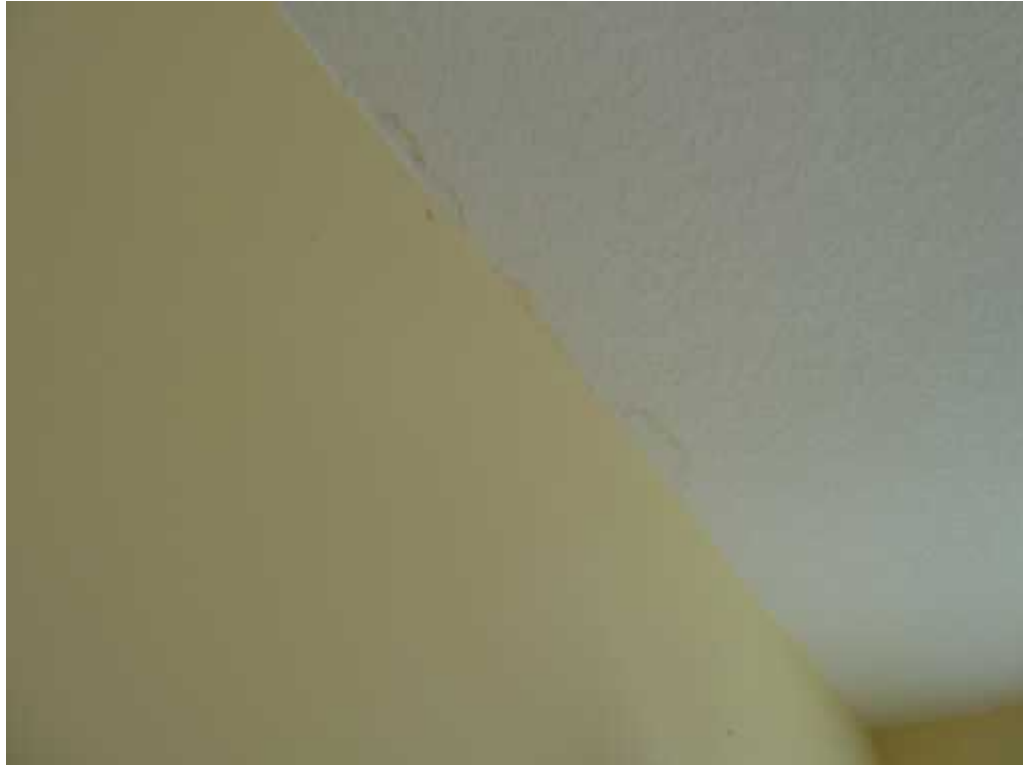
Ceiling in Right Front Bedroom

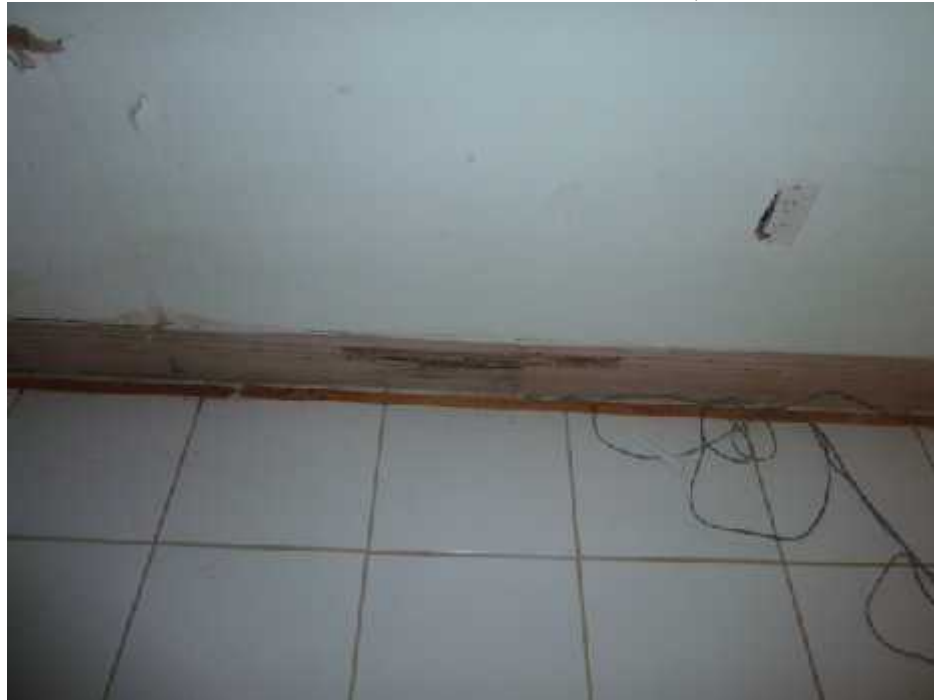
Water intrusion at Floors in Right Rear room.

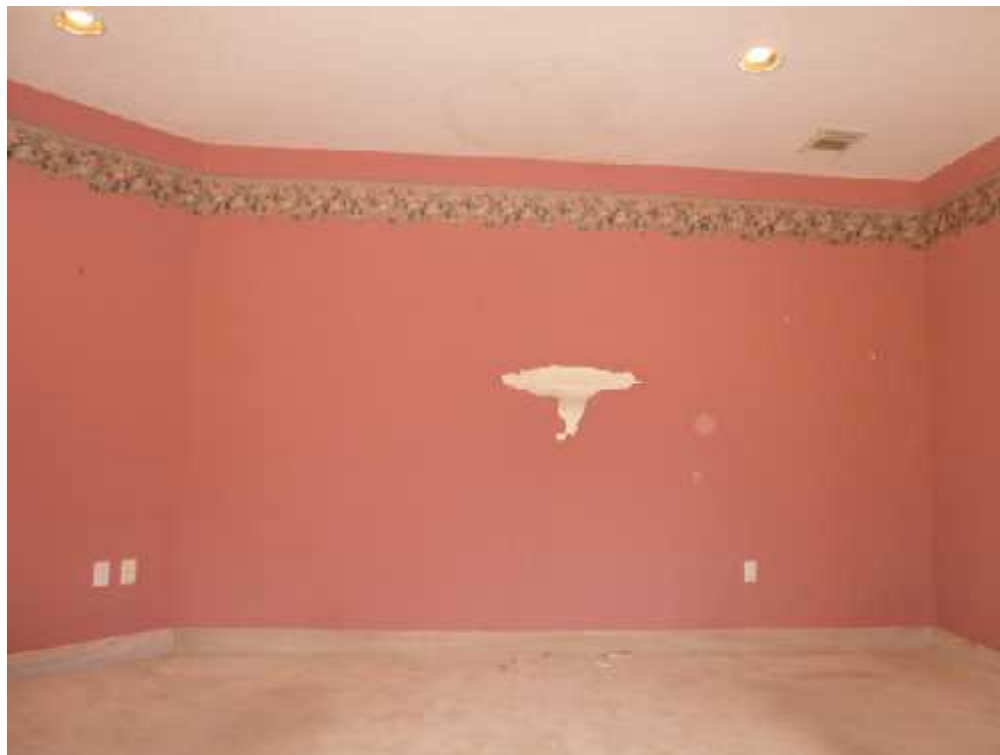
Water Damaged Ceiling and Walls in Master Bedroom

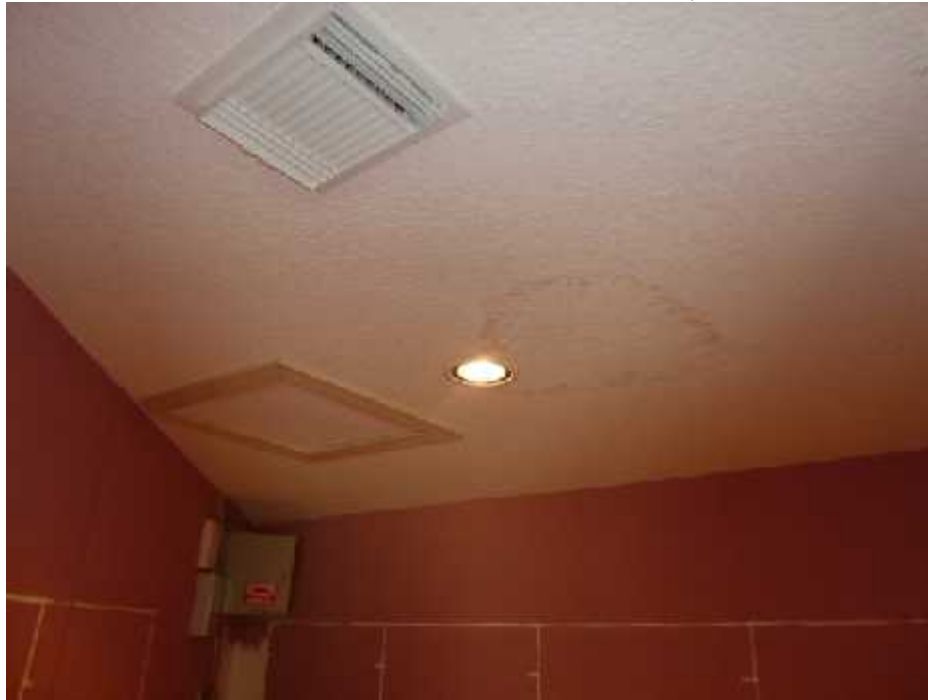
Ceiling in Master Closet

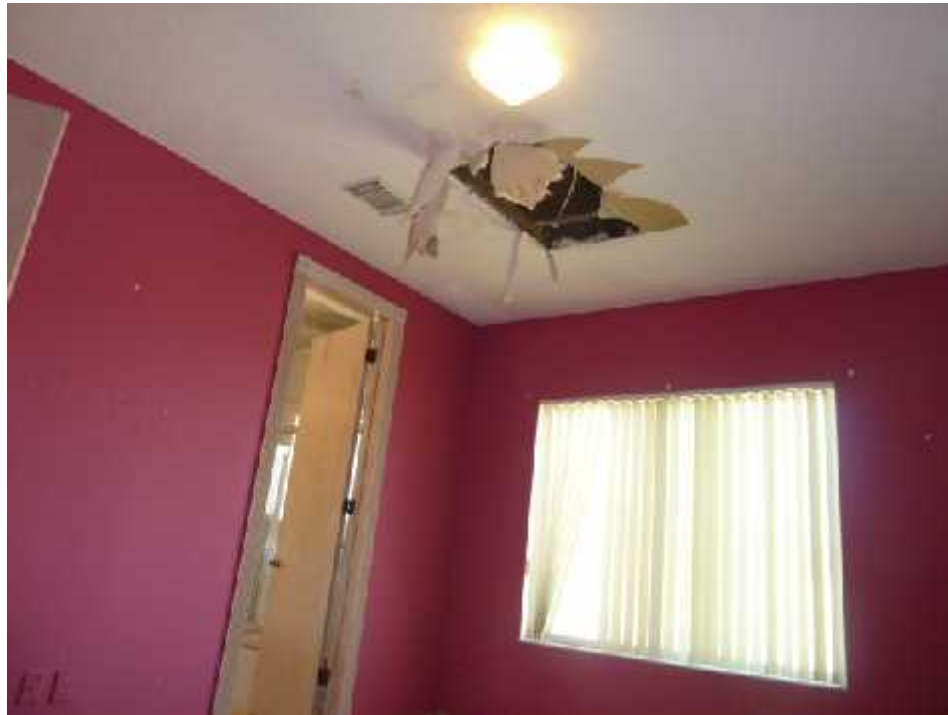
Ceiling Damage in Left/Center Bedroom

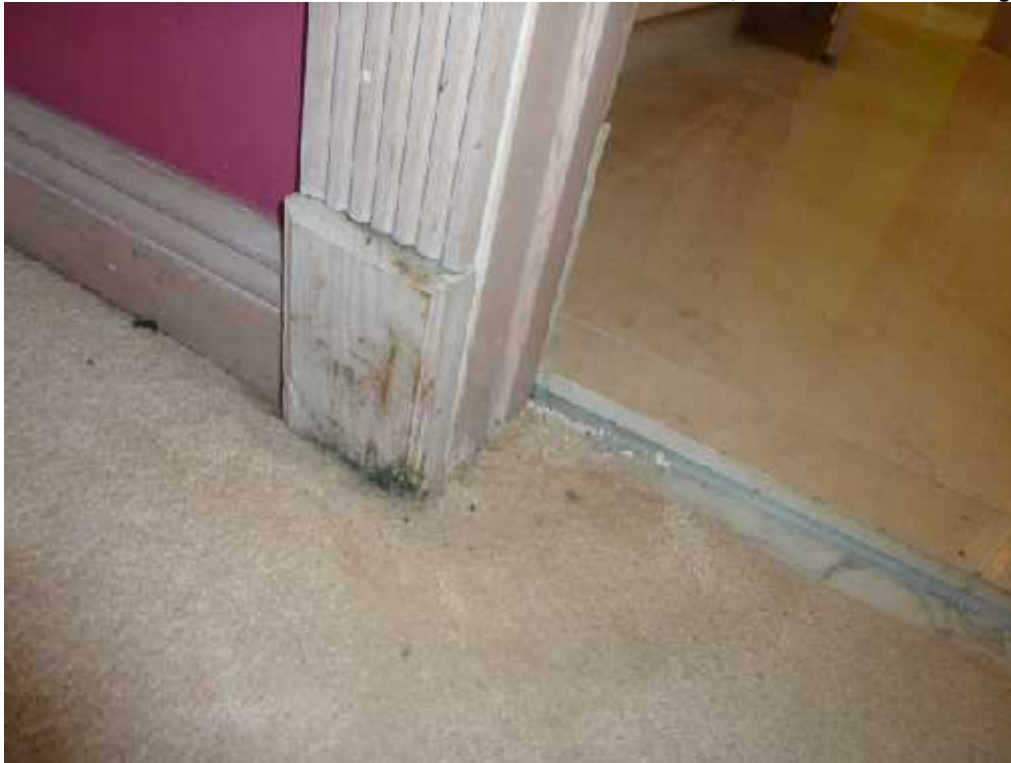
Water Damage to floor in Left/ Center Bedroom.

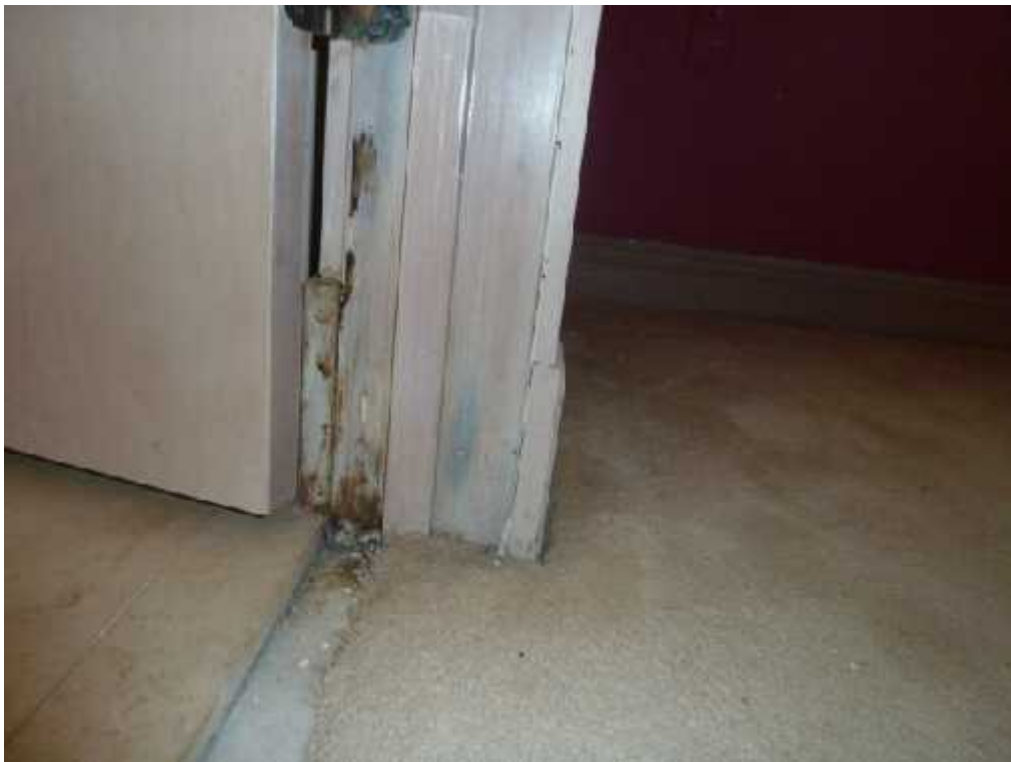
Water Damaged door and wall in Left/Center Bedroom.

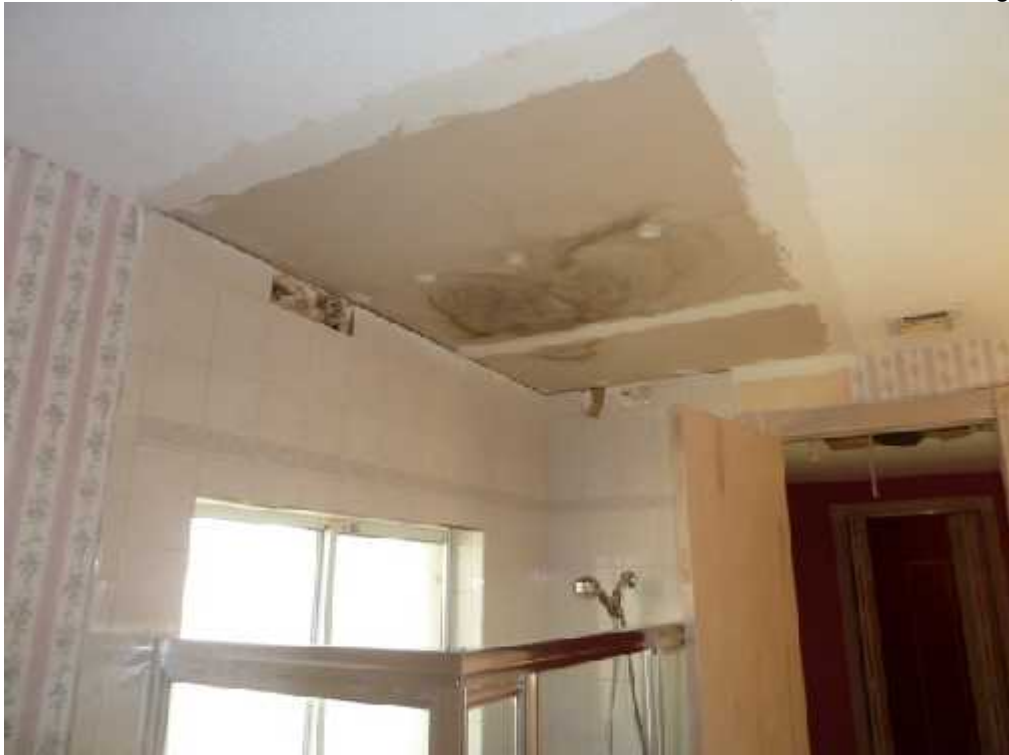
Water Damage in Hall Bathroom

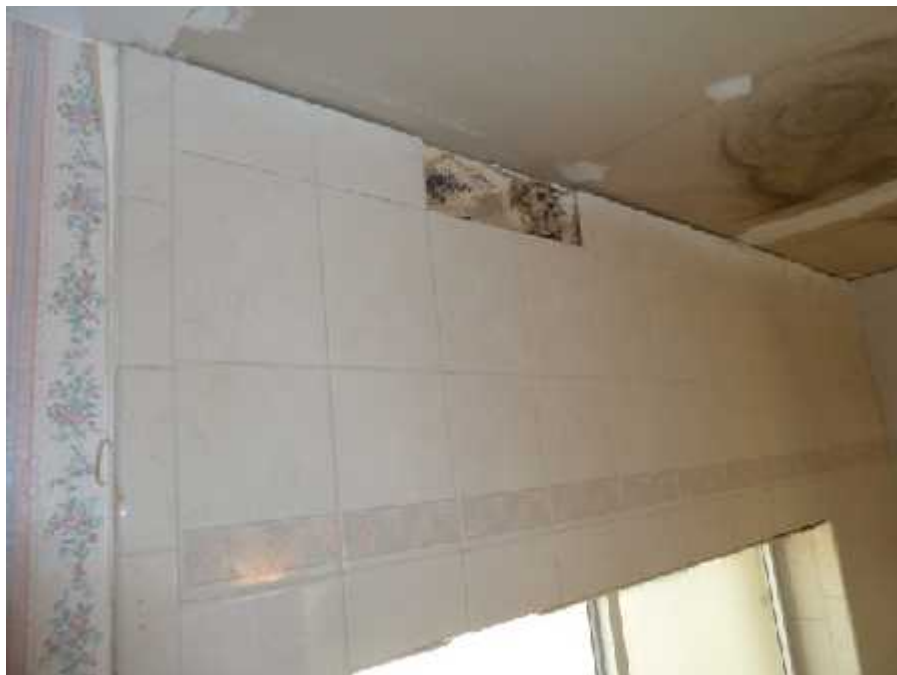
Damage also Behind Shower Tile

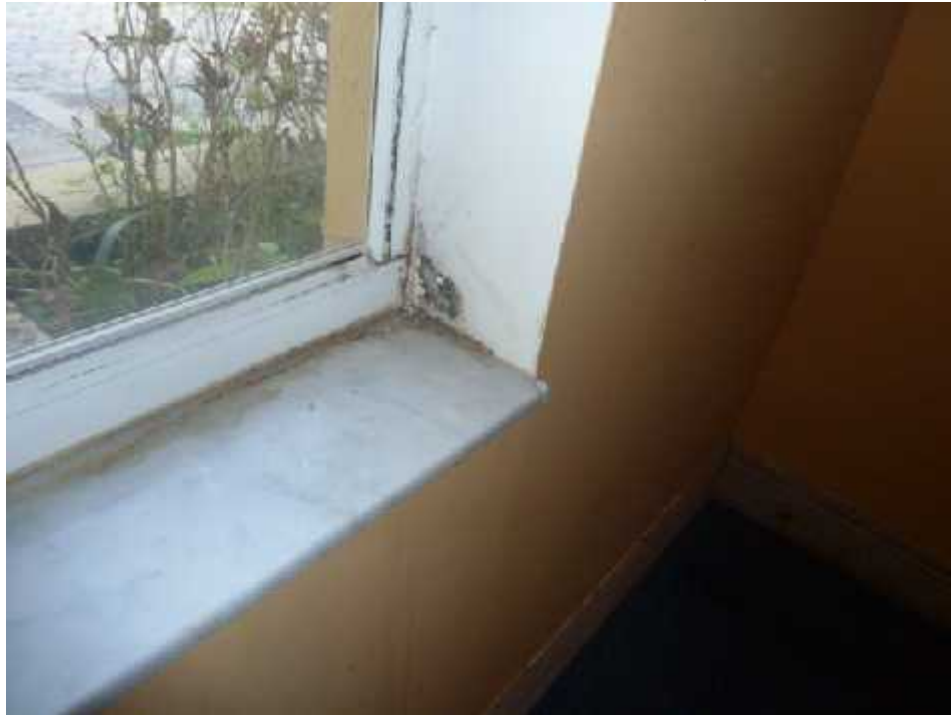
Water Damage at window in Left Front Bedroom.

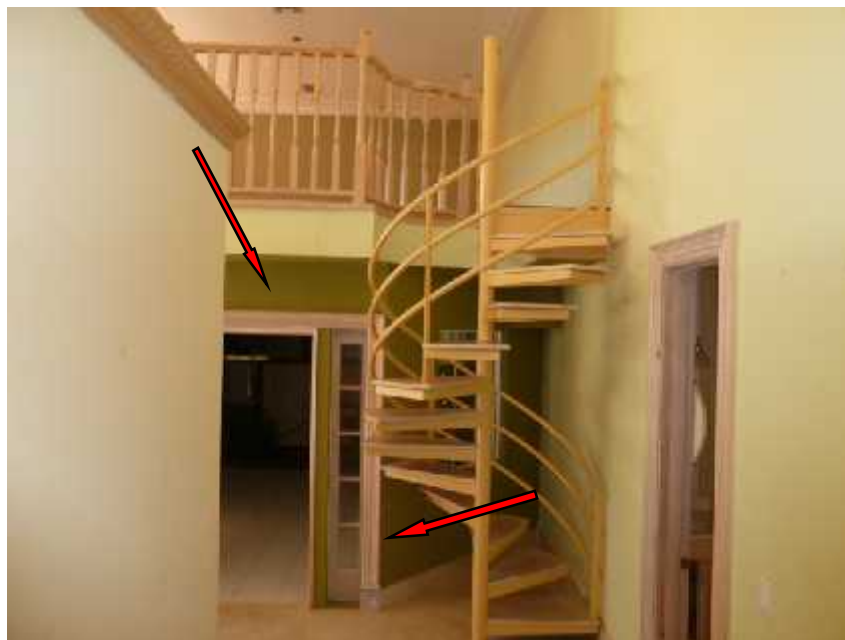
- Strictly based on the limited information available from our inspection, we suspect that some of the work and/or improvements to the property appear to have been accomplished without benefit of the required municipal building permit or periodic and final inspections. Of course, we suggest that you consult with the buildings present owners and if necessary, the municipal building department and refer to the building’s official permit history for this property. The building department’s official permit history will be the true arbitrator of fact.

Photo: View of the loft that we believe was constructed without the approval of local municipality.
