Building Inspection Report

11111 SW 111 St. Miami, FL. 33111

Inspection Date: August 11, 2011

Report Number:F080310

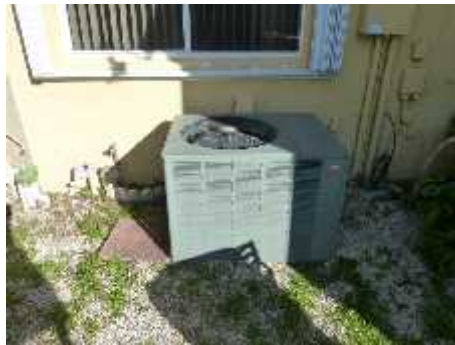
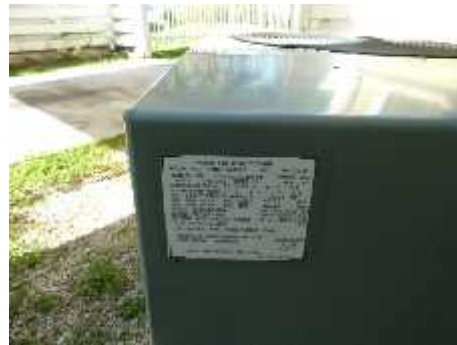
Coils in the compressor-condensing unit were examined to the extent reasonable and were found to be clean and in functional condition. This is normal.

PHOTO: View of the compressor

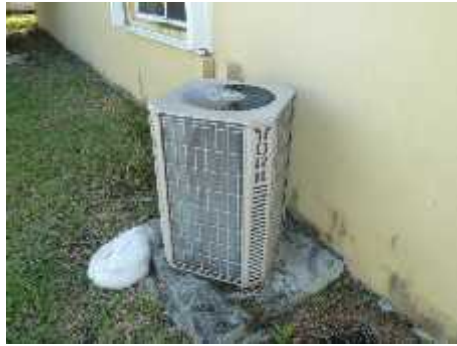
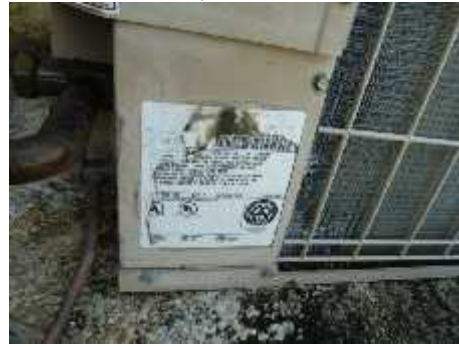
Coils in the compressor-condensing unit were examined to the extent reasonable and were found to be clean and in functional condition. This is normal.

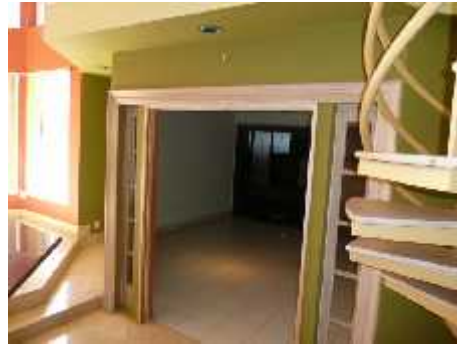
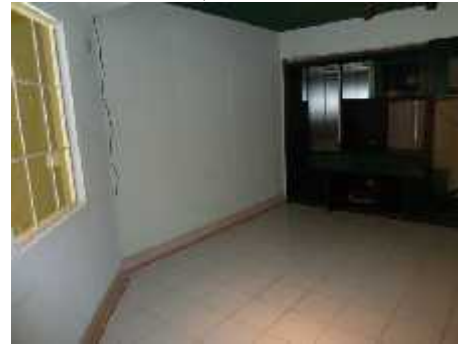
Photo: View of the loft that we believe was constructed without the approval of local municipality.
